SUSQUEHANNA RIVER BASIN
- WOLFF FARM DAM
PETERS ORCHARDS COMPANY

NDI NO. PA-01115
DER NO. 21-179

CUMBERLAND COUNTY, PENNSYLVANIA
PHASE I INSPECTION REPORT
NATIONAL DAM INSPECTION PROGRAM

APRIL 1981

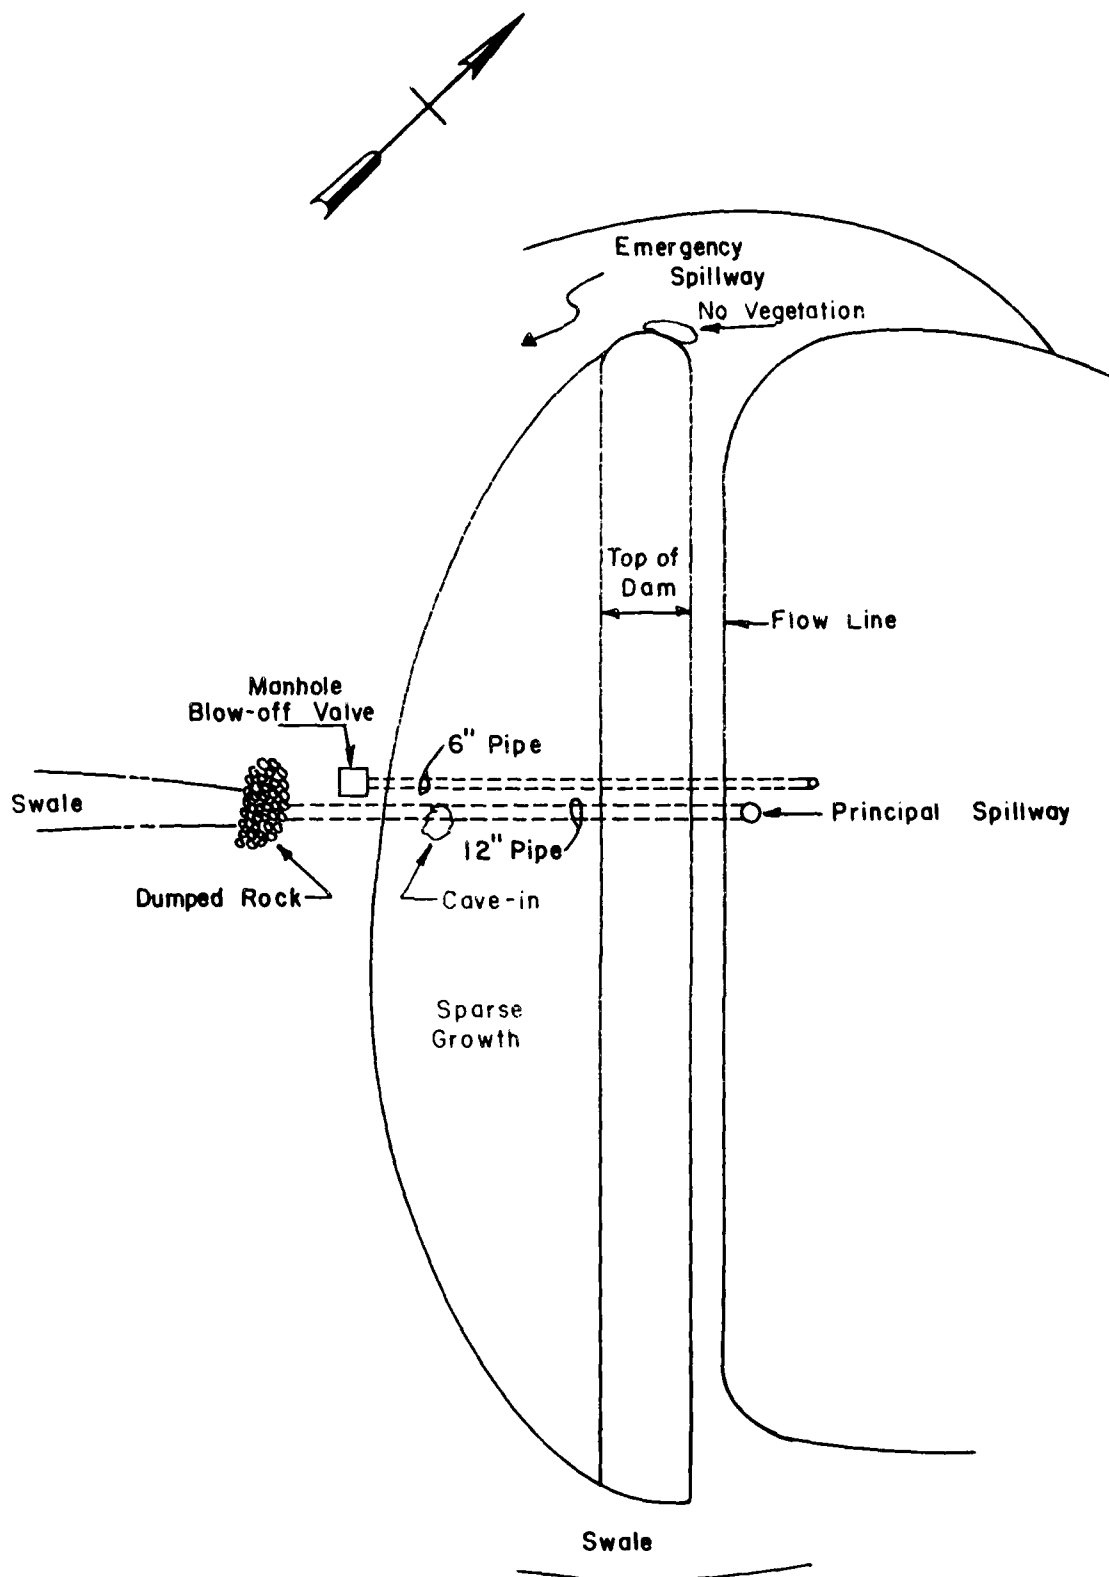
WOLFF FARM DAM
PA-01115
INSPECTION SURVEY
PLATE A-I

The exposed upstream slope below normal pool level is about 3.5H to 1V. The crest of the dam is on a straight alignment and has a well maintained grass cover. The surveyed profile (Plate A-II, Appendix A) indicates about half a foot variation in elevation along the crest and a low swale beyond the left abutment. This swale has a good grass cover and can be used as an overflow section. The downstream slope is uniform with a sparse growth of mowed weeds (Photographs No. 4 and No. 7). The exposed embankment surface consists of a sandy soil and could be easily eroded if overtopping would occur. A small subsidence area was noticed near the downstream toe over the 12-inch principal spillway outlet pipe. It is possible that a leak exists in the outlet pipe in this area and is the source of the settlement.

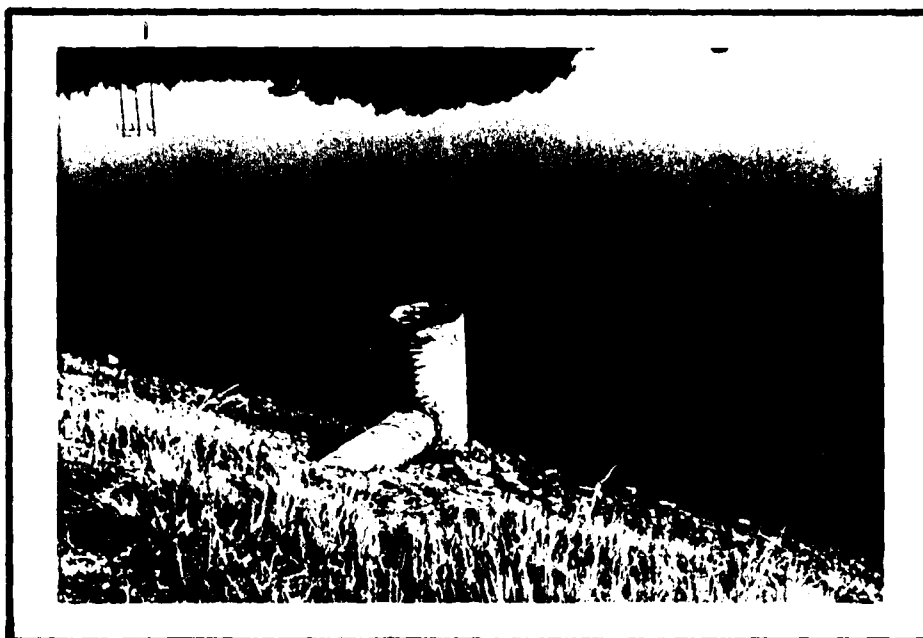
The principal spillway consists of an 18-inch drop inlet pipe which discharges through a 12-inch corrugated metal pipe (Photograph No. 6). This spillway was installed after the 1972 Agnes storm to reduce the flow through the grassed spillway in the right abutment. The outlet pipe was constructed close to the surface through the embankment (Photograph No. 7). The pipe daylights at the downstream toe. To prevent erosion, heavy riprap has been placed over the outlet, reducing

DETAIL OF PRINCIPAL SPILLWAY INTAKE - NO. 6

The rock protection at the outlet pipe should be rearranged so as not to block the open end of the pipe.
